TRANSPORTATION SAFETY

REFLEXIONS

Issue 27 – March 2004

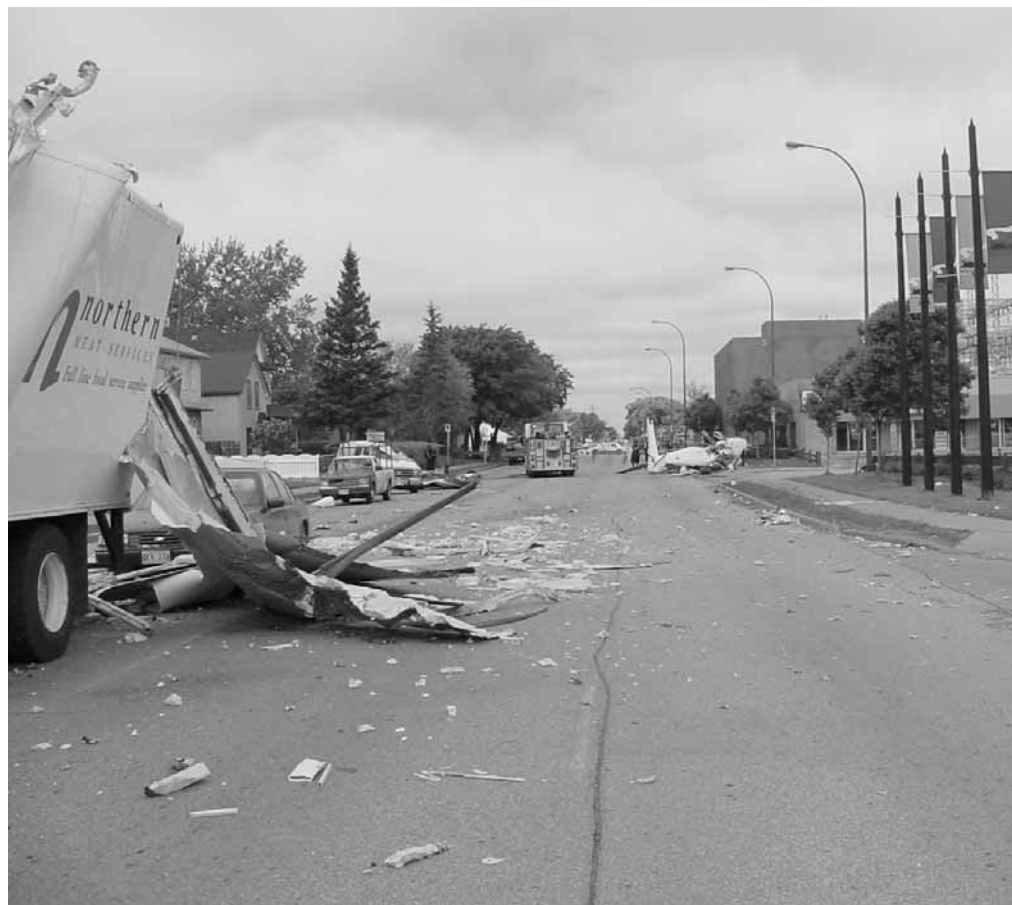
View along wreckage trail to show vehicular strike

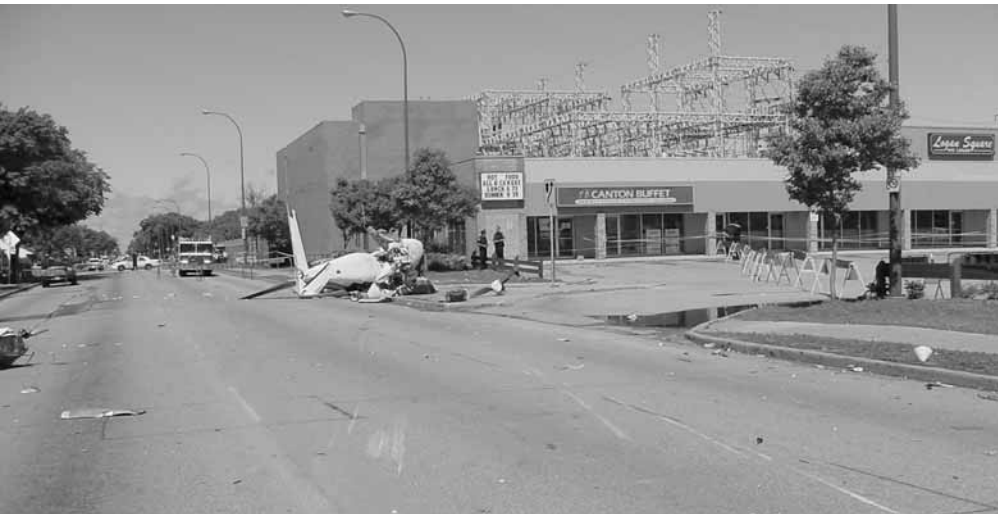
View to illustrate the proximity of a restaurant

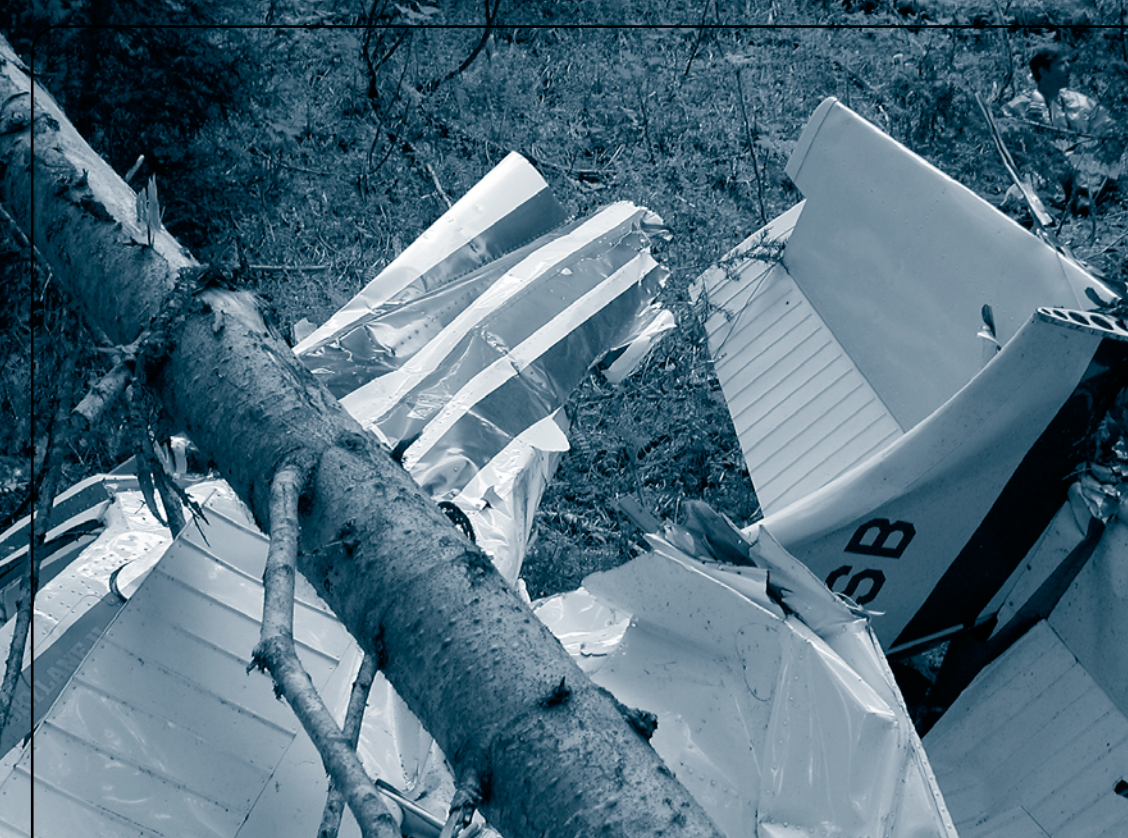
The aircraft struck a tree before the pilot was able to regain control.

When he encountered rising terrain and lowering cloud, the pilot probably lowered the aircraft's nose to avoid entering cloud and started a turn to reverse his course. Because no horizon was visible when looking outside the aircraft, the only way to maintain control during this turn would be by reference to flight instruments. For unknown reasons, the pilot lost control of the aircraft, entered a spiral dive and, given the relative proximity of the terrain, the aircraft struck a tree before the pilot was able to regain control.

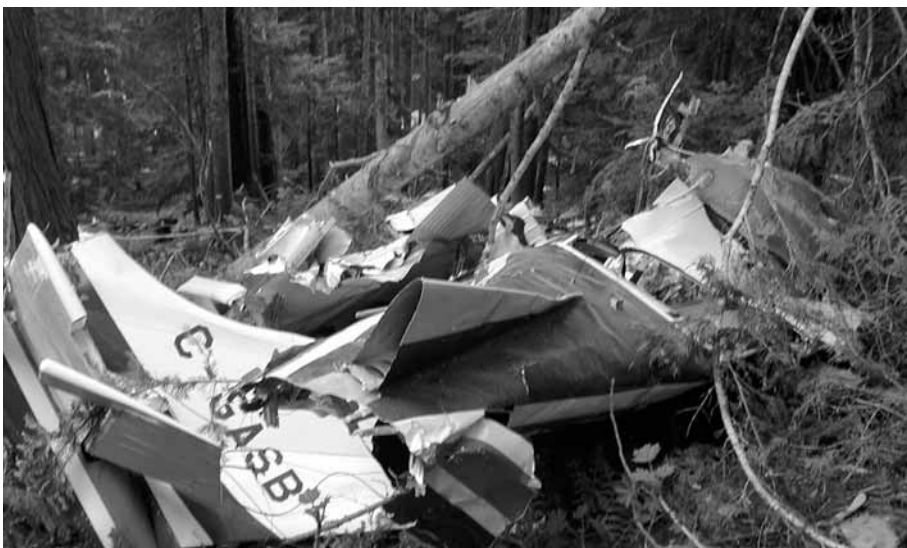
The wreckage was located by a search aircraft the same day, less than one nautical mile from the Coquihalla highway.

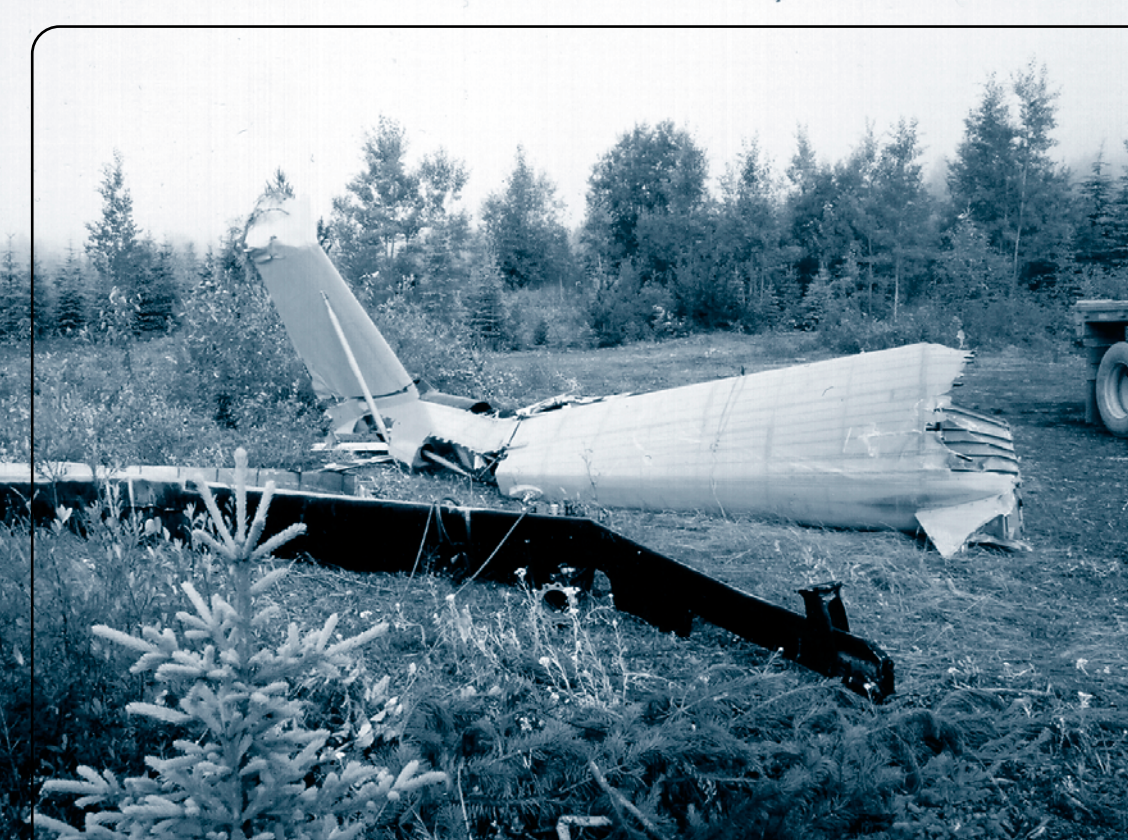
Dual failures of the input freewheel unit led to the loss of this helicopter.

The left and right IFWUs had been overhauled by the operator, Croman Corporation, on 12 September 2001, using new camshafts, roller retainers, rollers, supports (oilites), gear housings and gear housing bearings. At the time of the accident, the IFWUs had accumulated 532 hours, which is within the recommended time between overhaul (TBO) of 500 ± 50 hours for IFWUs used for repetitive external lift (REL) operations (this TBO had been recommended by Sikorsky as a direct result of the finding of increased IFWU wear in REL operations noted in TSB Report No. A93P0051). Following the accident, the IFWUs were disassembled, inspected, and several component parts were tested. The right and left IFWUs exhibited similar wear and damage.

Metallographic examination of the area around flat spots on the rollers showed an untempered martensite surface layer. Skidding and spit-out of the rollers is the most likely cause of these metallurgical anomalies. The rollers were

not through-hardened to the required specification during their manufacturing process. It is not known what effect this defect may have had on the IFWU's ability to maintain engagement. Wave-shaped areas of raised metal on the camshaft flats on the low (disengaged) side of the roller impressions indicate that the rollers were forced in the disengaged direction with extreme and unusual force. Other damage to the IFWU components—smearing of the roller metal, denting and pitting of the gear housing roller path, and breakup of the oilites—is also indicative of damage caused by slipping and spitting out.

Damage to the oilites can cause a loss of support to the roller retainer. This in turn can cause a loss of alignment of the rollers, which increases the likelihood of roller spit-out. During normal operation, the oilites are stationary and do not carry a load. However, a quantity of fine bronze particles was found in the oil, indicating that the oilites were subject to repeated small loads and motions, such as would occur as the result of vibration. Contamination of the roller path with oilite material increased the likelihood of roller spit-out.

Sikorsky issued Alert Service Bulletin (ASB) No. 61B35-67A, dated 11 October 2002. In part, the ASB reduced the TBO for IFWUs used for repetitive external lift operations from 500 hours to 350 hours. The ASB also required that certain IFWU components be measured and inspected during disassembly for overhaul, and that these measurements, as well as details of the condition of the components, be forwarded to Sikorsky.

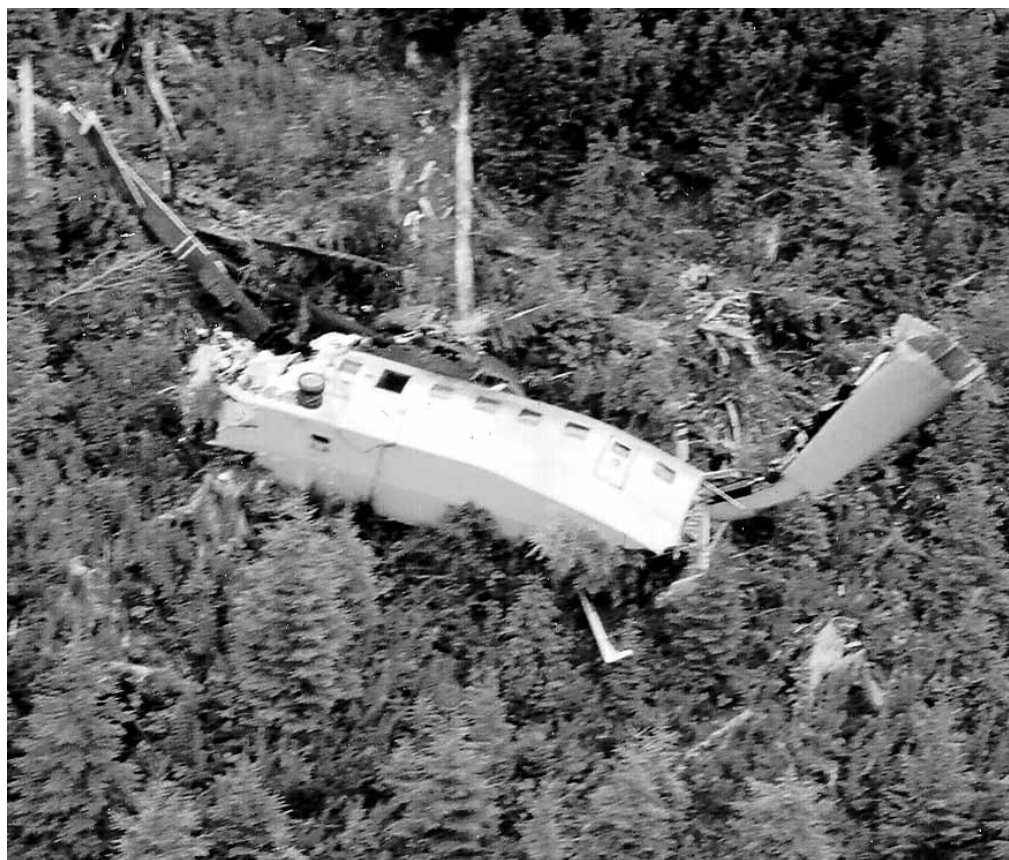
It is unlikely that the helicopter entered fully developed autorotation descent.

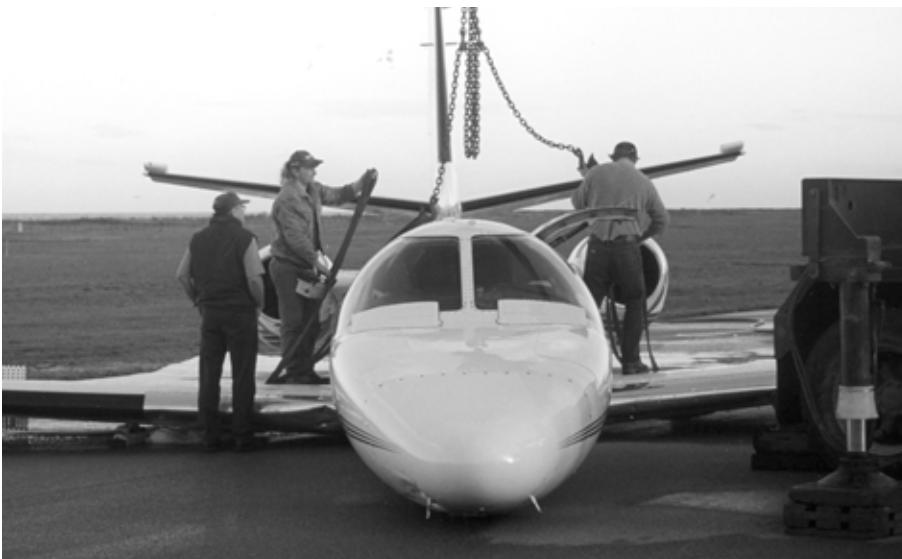
Straps are attached to the fuselage of the Citation.

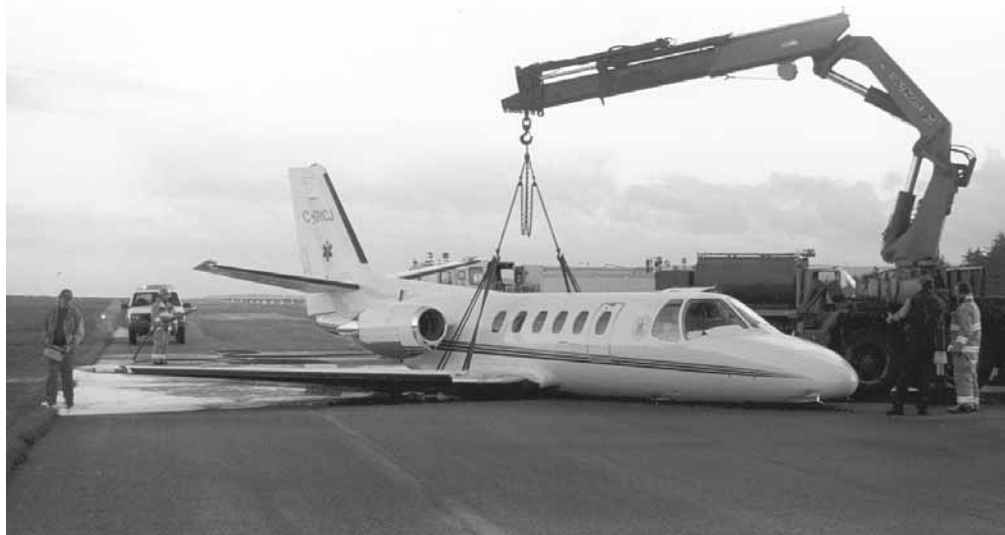
The Citation is raised so that the landing gear can be extended.

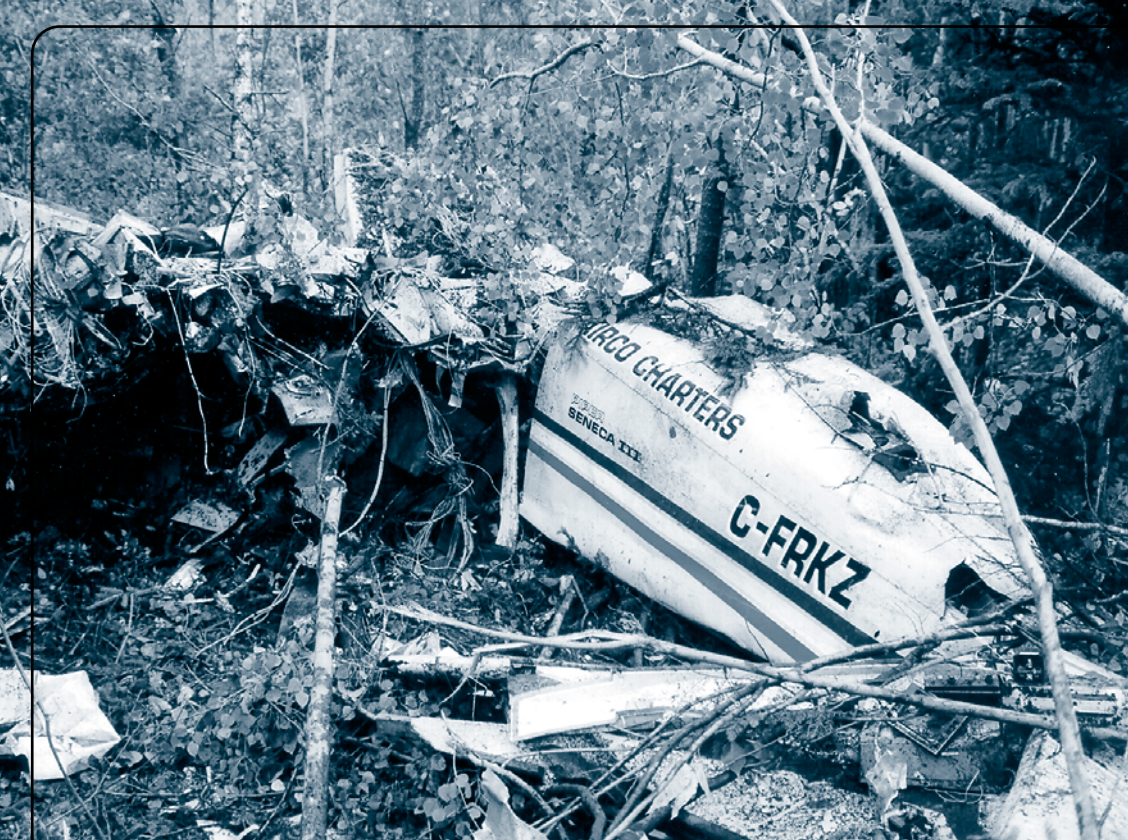
It is not known why the pilot of this Piper Seneca descended below the minimum descent altitude.

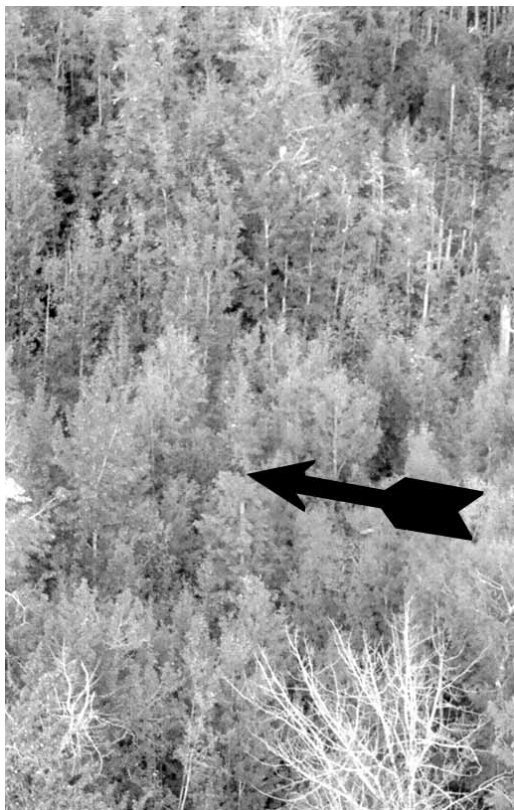
The configuration of the aircraft and the 360-foot-long wreckage trail are indicators that the

aircraft struck the trees in a fairly steep dive with a considerable amount of speed. Because of the severity of the impact, limited information was available as to the aircraft's performance and functionality.

The plane crashed into a densely wooded area.

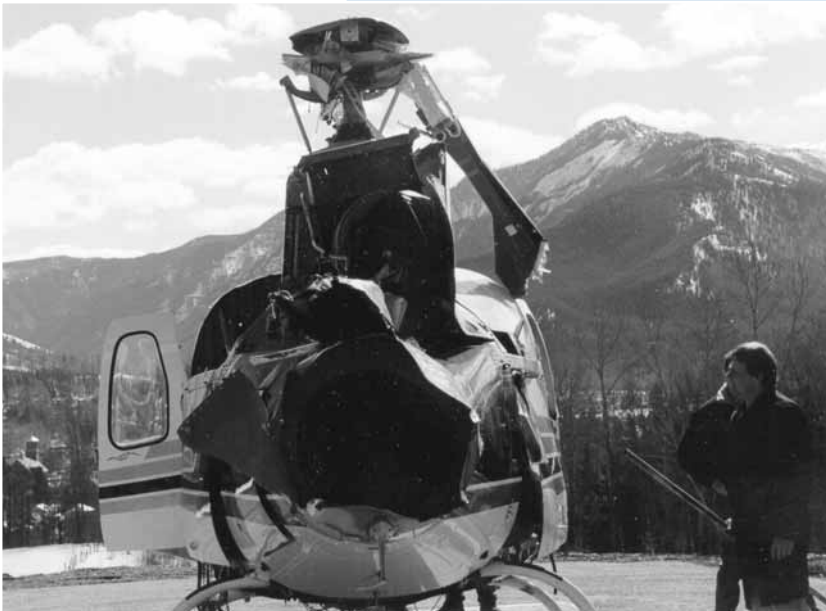
Wind conditions most likely exceeded the helicopter's performance limitations.

Winds at the site, as forecast and as reported by surrounding stations, were probably from the south or southwest at speeds of 20 to 40 knots, resulting in subsidence, turbulence, and wind shears on the east (lee) side of the mountain. An updraft on final approach caused the pilot

to lower the collective slightly; this was probably followed by a downdraft, or wind shear, which caused the helicopter to suddenly descend. From an altitude of approximately 50 to 100 feet above the trees, at a near-hover speed, there was little margin for the helicopter to recover. The maximum rate of climb of the helicopter, at the altitude and load, was about 1500 feet per minute (fpm), in downdrafts that could have exceeded 3000 fpm.

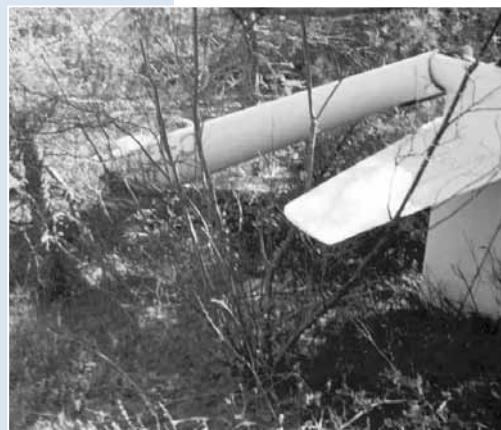
Wreckage of the Cirrus glider

During the accident launch, acceleration forces would have effectively pressed the pilot rearward, transferring high load forces to the seat and its attachment hardware. Two of the three forward seat attachment bolts were found detached. The shiny appearance of the threads on the right anchor nut was likely due to the bolt tearing out, which would suggest that the bolt in the right anchor nut was only engaged by a maximum of four threads. Ordinarily, this amount of thread engagement would be sufficient to provide the maximum strength of the bolt and anchor nut assembly. However, in this occurrence, the threads had been previously damaged by cross-threading, and the assembly may not have been able to develop the full clamping force. It could not be determined why the bolts were not completely fastened.

Although there was not enough information available from the engineering analysis to determine whether the bolts pulled out in the air or at ground impact, other information supports the conclusion that the bolts pulled out in the air. The glider pitched up excessively a short time after lift-off. This was certainly abnormal and no fault was found with the glider’s control system or structure. It was concluded that the combined effect of the cross-threading damage, the probability that the centre and right bolts were not fully engaged, and the acceleration forces of the launch resulted in the bolts pulling free from the anchor nuts, resulting in seat failure. When the seat failed, the pilot would have moved downward and aft, away from the controls. This sudden rearward movement would have resulted in a corresponding rearward control stick movement, and an abrupt pitch upward, with subsequent loss of control. In addition, the pilot would have been unable to reach the manual tow cable release.
